EFFECT OF ANGLE OF INCIDENCE OF SECOND-STAGE VANE

ASSEMBLY ON THIRD-STAGE COMPRESSOR-BLADE

VIBRATION AND ENGINE PERFORMANCE

RESEARCH MEMORANDUM

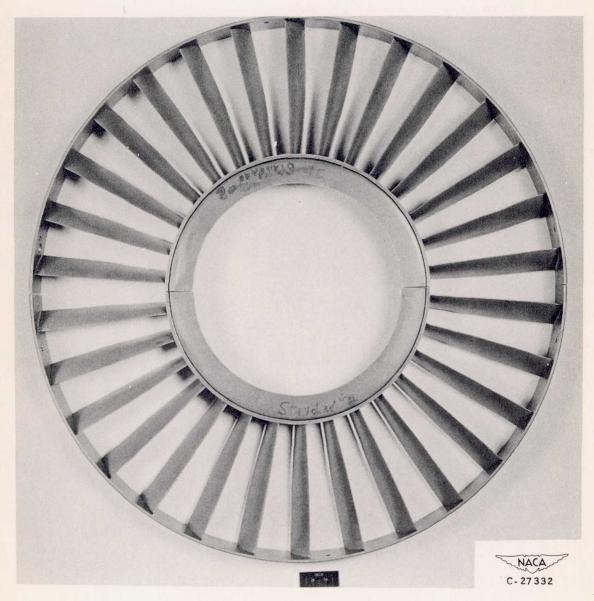
Figure 1. - Second-stage vane assembly.

After the third-stage vibration had been detected, a series of tests followed which included the testing of a series of second-stage stator-vane assemblies (fig. 1) with various angles of incidence. The assemblies tested included 6° open, 0° (standard), 3° closed, 6° closed, 9° closed, and 12° closed. The standard vane is the vane assembly normally furnished with the engine, and the closed angle indicates a vane with higher angle or incidence.
